12.16.18 BSAR River Update:*

"Good Weather, Good People, and Good Work Getting Done"

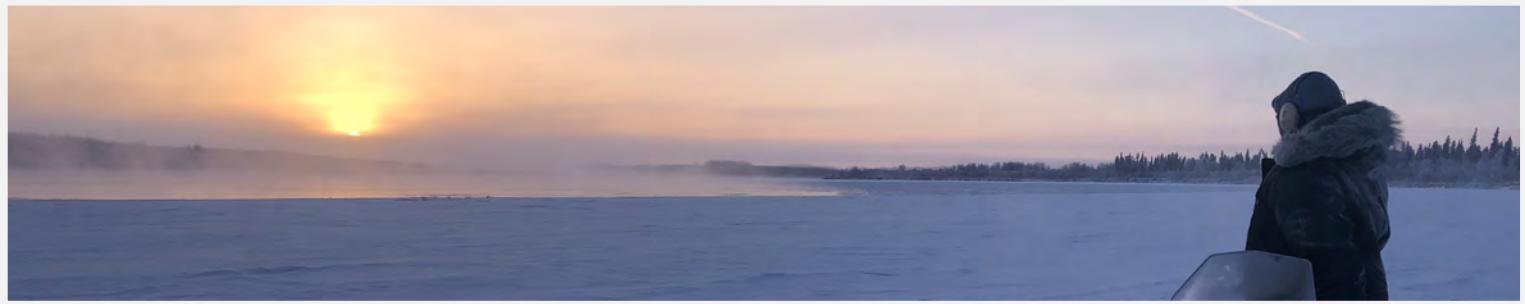
A BSAR Member watches the sunset over an unmarked open hole steaming in the minus twenty air temperature 90 miles above Bethel

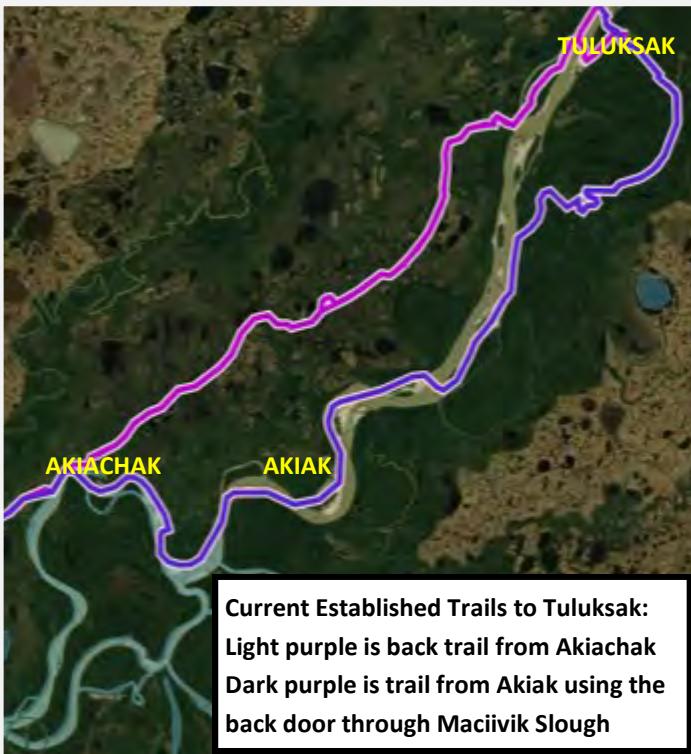
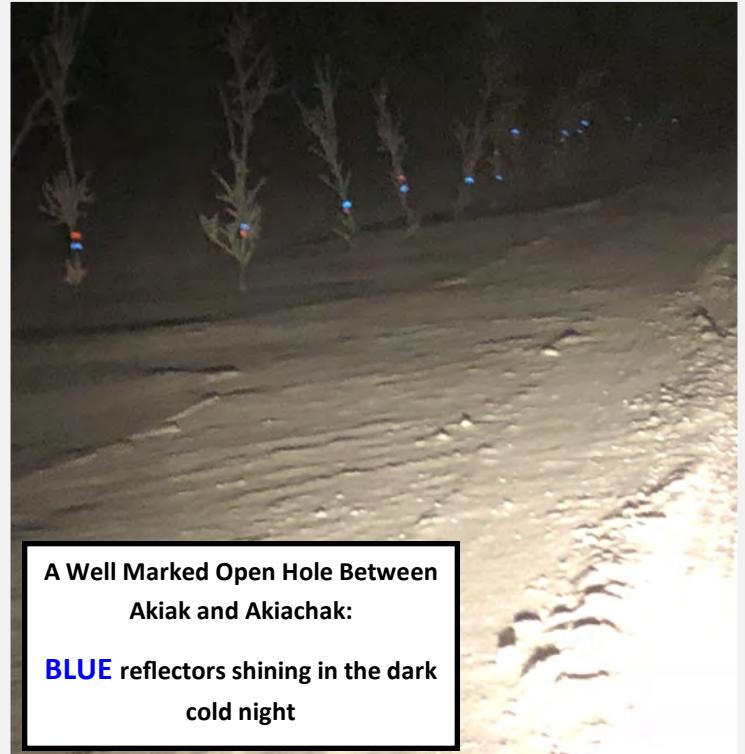
- No open water from Akiak to Tuluksak has been marked
- There are now two main established trails to Tuluksak. One is partially in the River then portages into Maciivik Slough and goes into Tuluksak by the back door near the airport. The other is the back trail (cross country) trail from Akiachak (SEE MAP)

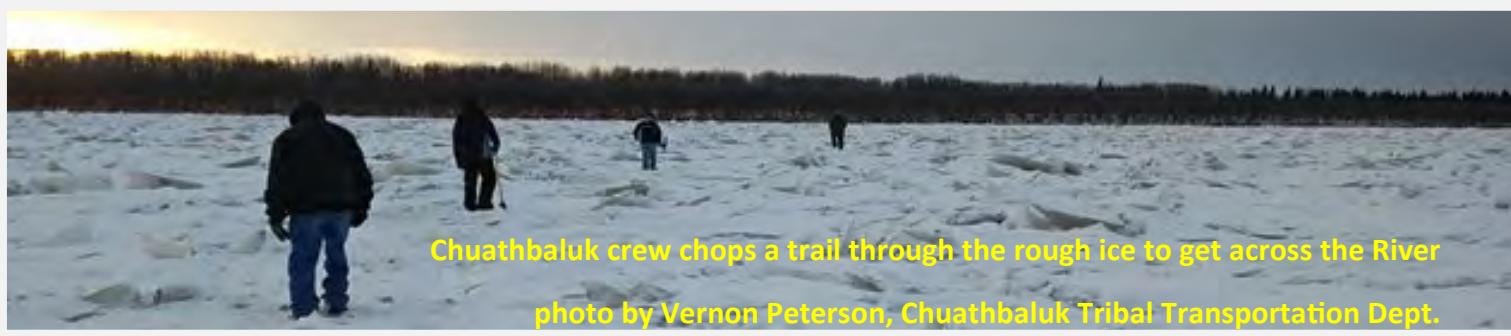
All along the River crews have been out working in the cold installing thousands of willow markers with BLUE reflectors around open water areas

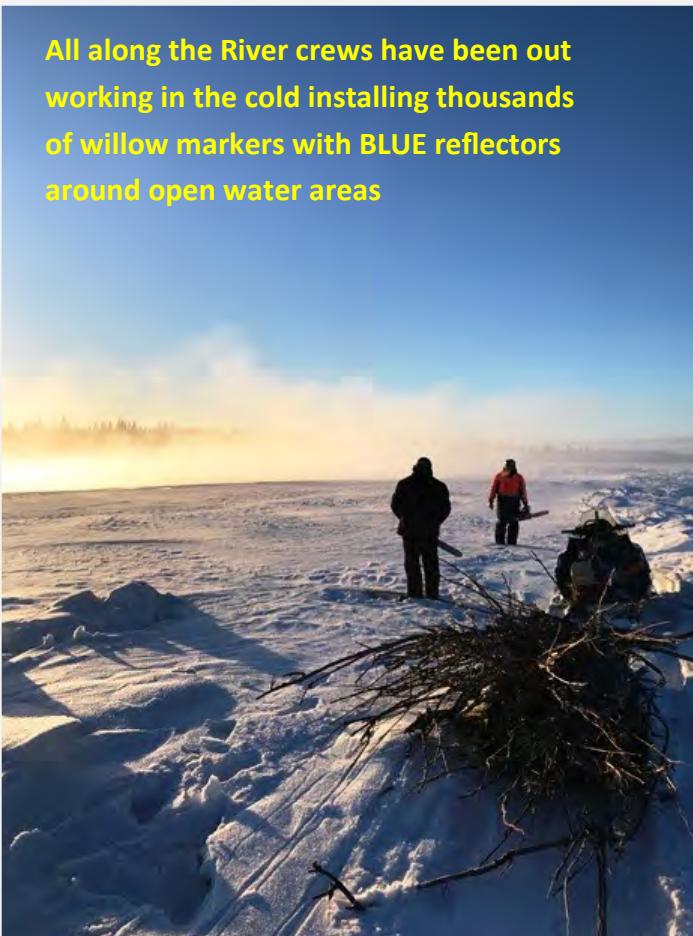
This is the Kalskag/NVN crew working 12 miles below Lower Kalskag near Iftikum's fish camp

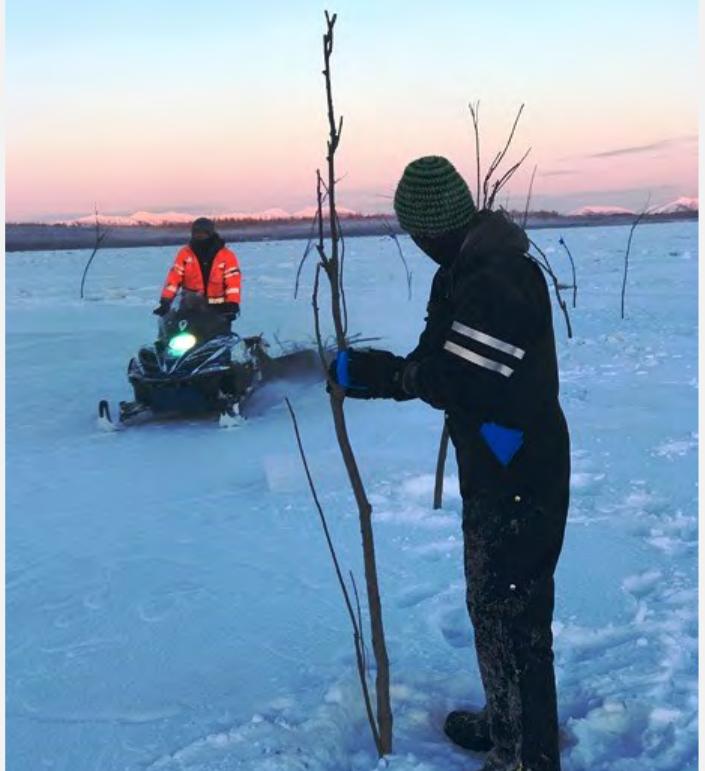
A well marked open hole steaming in the twilight

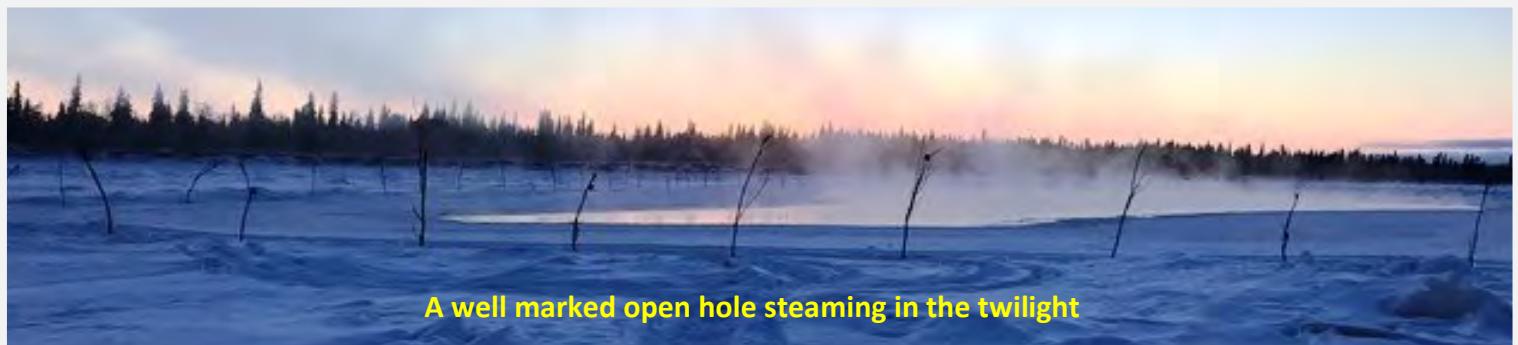
A large open hole can create fog that spreads for miles

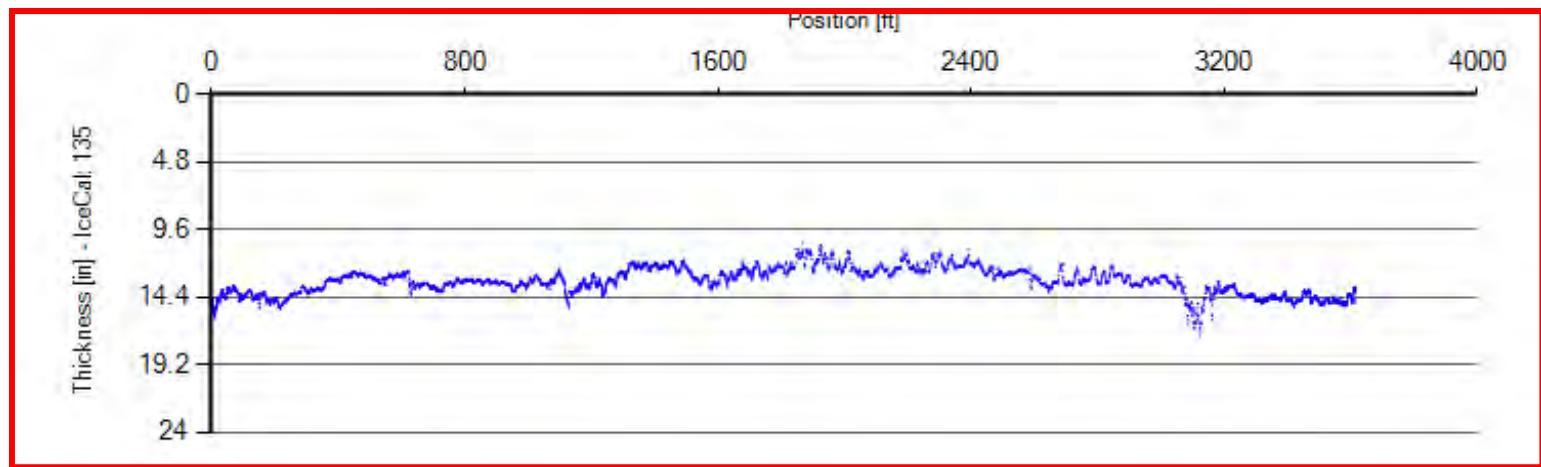
Top Graph: Ice thickness in front of Bethel from Hospital Landing to Lomack Beach on 12.14.18. Look at the inches on the left side and the blue line. You can see that near the beach is thicker and the middle is thinner.

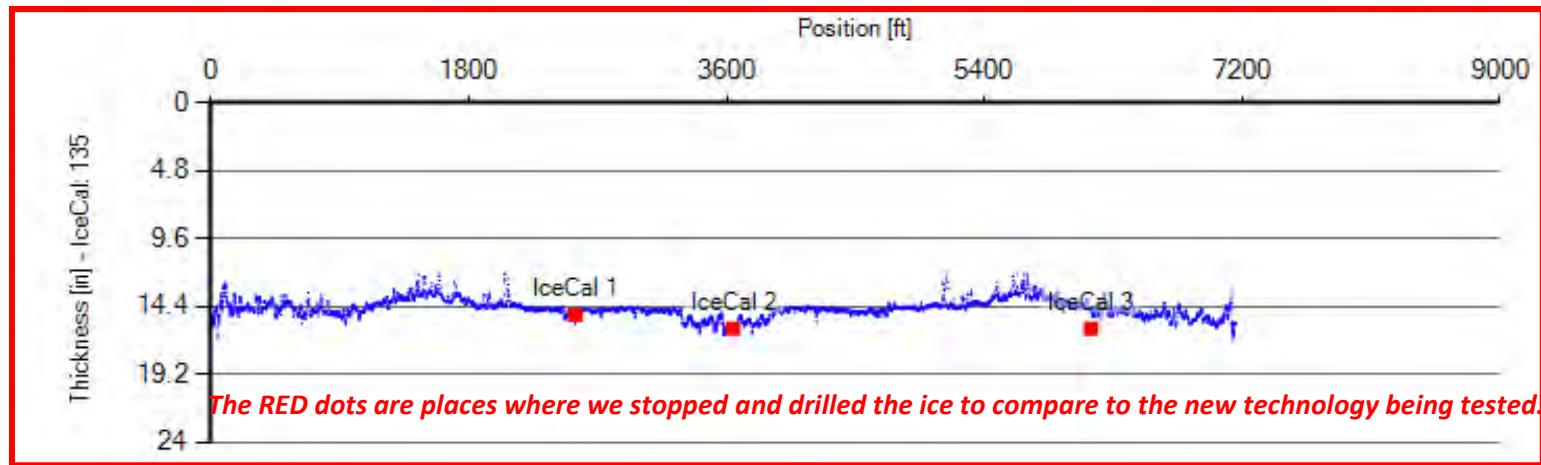
Bottom: Same track line on 12.16.18. Notice the increase. But the channel in front of Bethel has slower current. It freezes earlier and more quickly than the other main channels of the Kuskokwim.

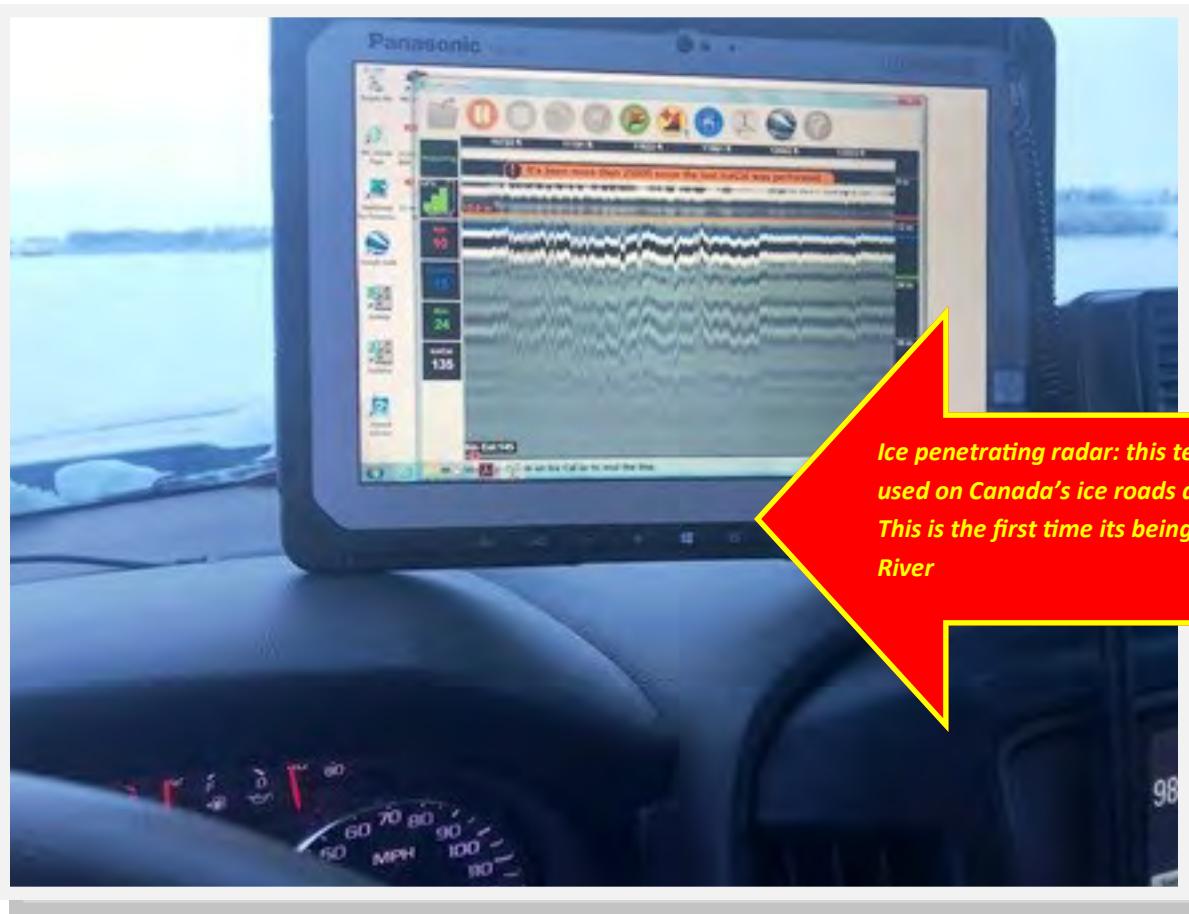
Ice penetrating radar: this technology is already being used on Canada's ice roads and on Alaska's North Slope. This is the first time its being tested on the Kuskokwim River

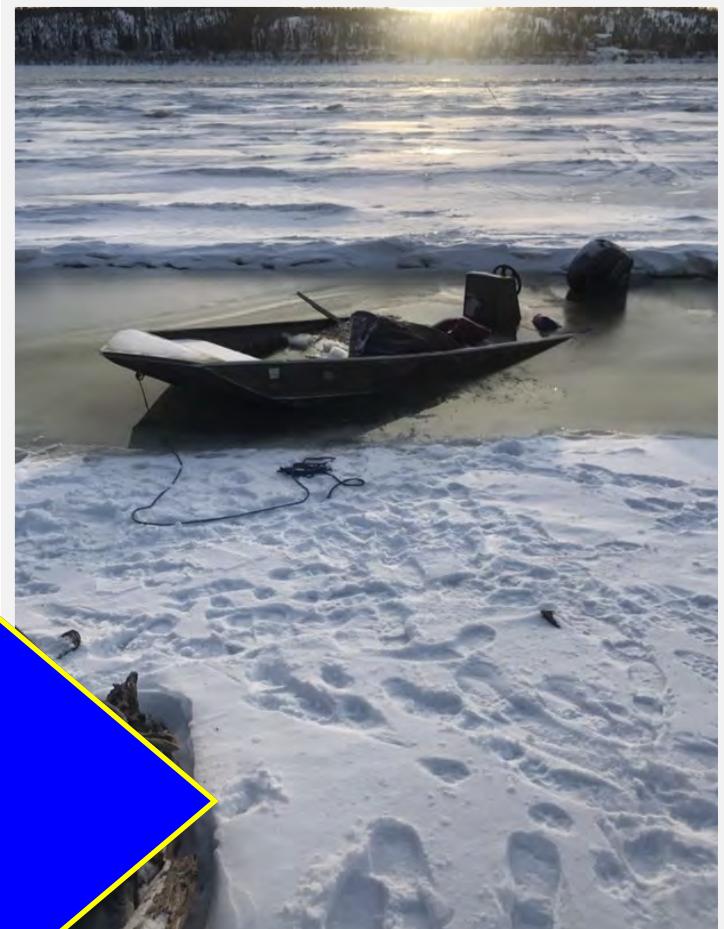
The ice stopped at Crooked Creek on December 12. Up river when the ice stops there is a rapid rise in water level. This boat got caught in it but was pulled out before it froze in. Photo courtesy of Tim Zaukar
