*12.10.19 BSAR River Update—Report 2019-03**

“The Danger of Blue”

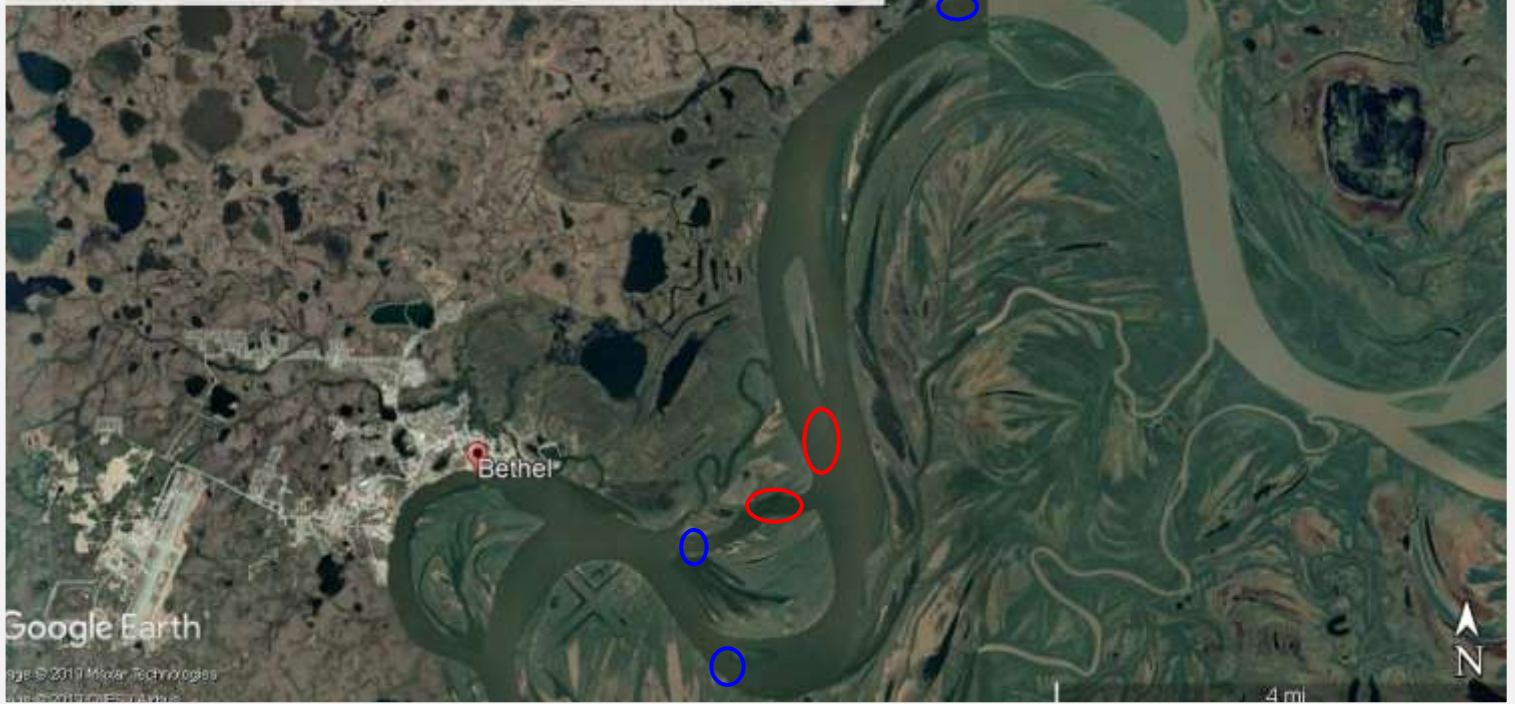
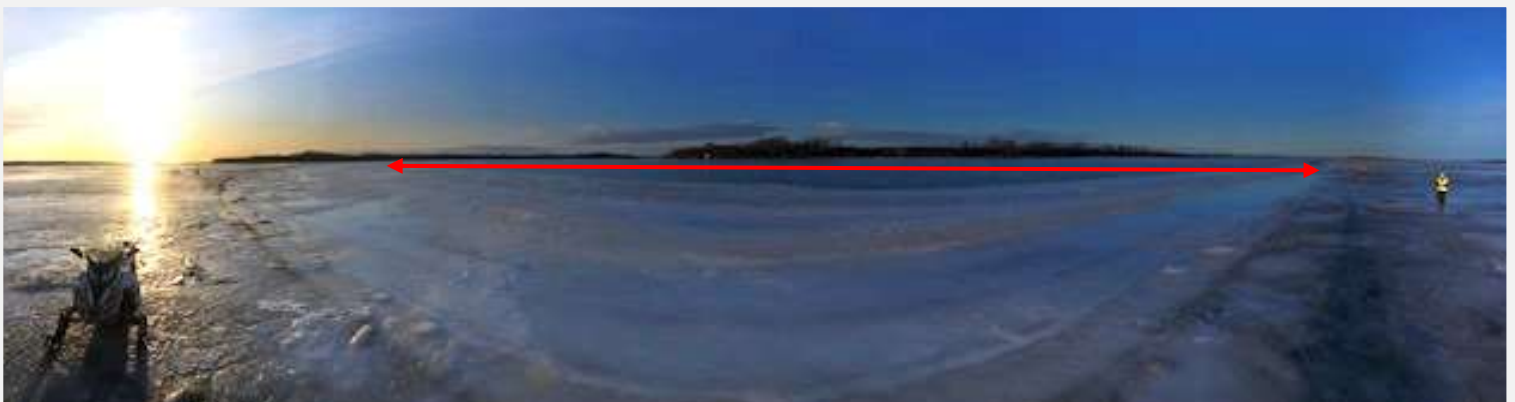
12.10.19 KNOWN OPEN WATER IN THE BETHEL AREA

RED CIRCLES ARE UNMARKED OPEN WATER

BLUE CIRCLES ARE MARKED OPEN WATER

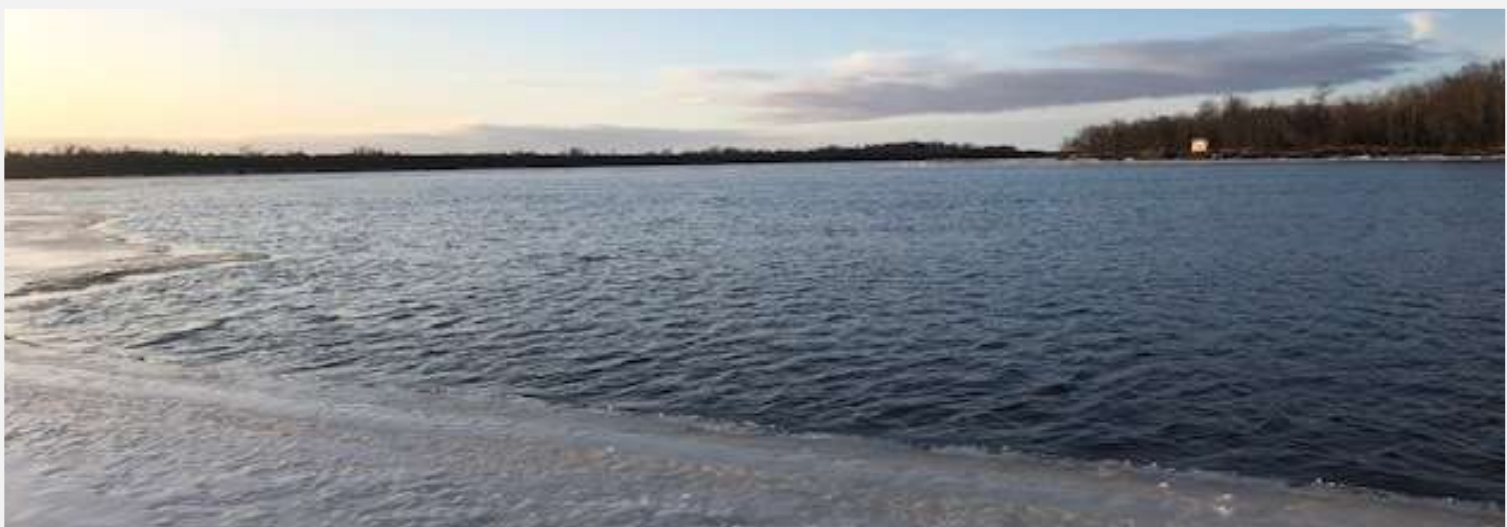
*Panoramic View of "AC Store" Sized **UNMARKED** Open Hole in the Main Kuskokwim Between Straight Slough and Schwabe Island*

If you are willing and able to help mark the big open hole above Bethel this weekend please call the number at the top of this report or 545-2877

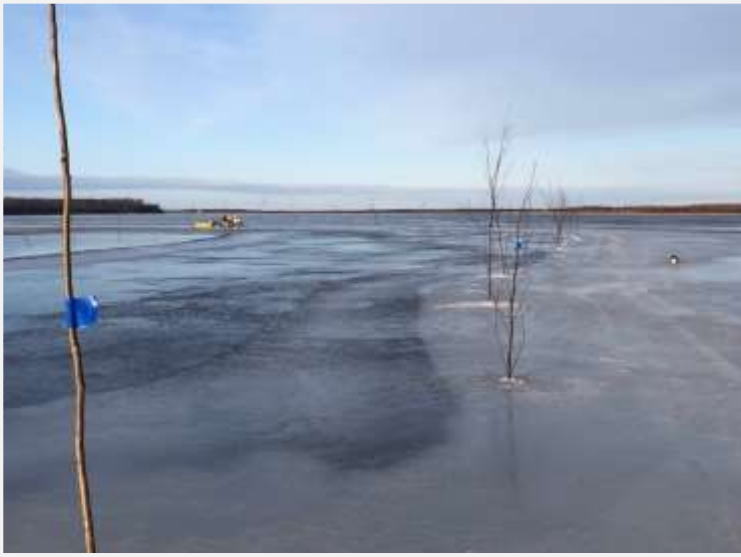
*Looking Across the Open Water to Straight Slough— Marking this one will be a big job requiring 100's of willows & **BLUE** reflectors*

BSAR will need help

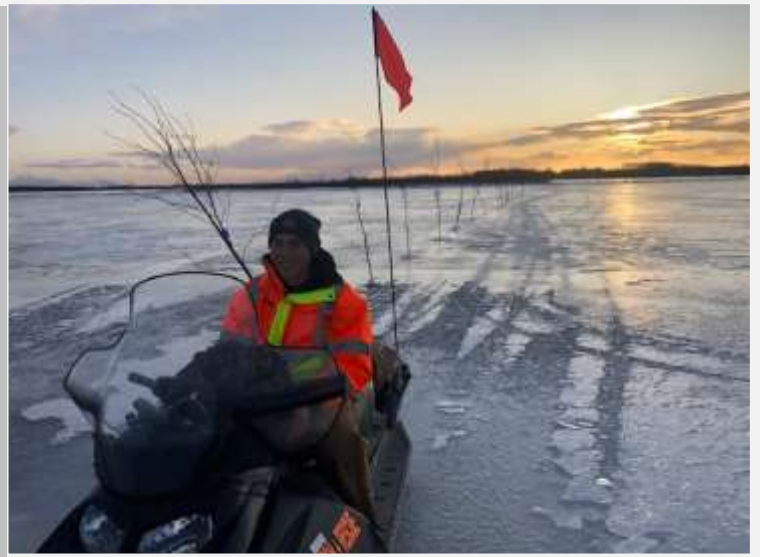
Marked Open Hole by Joe Pete's Fish Camp

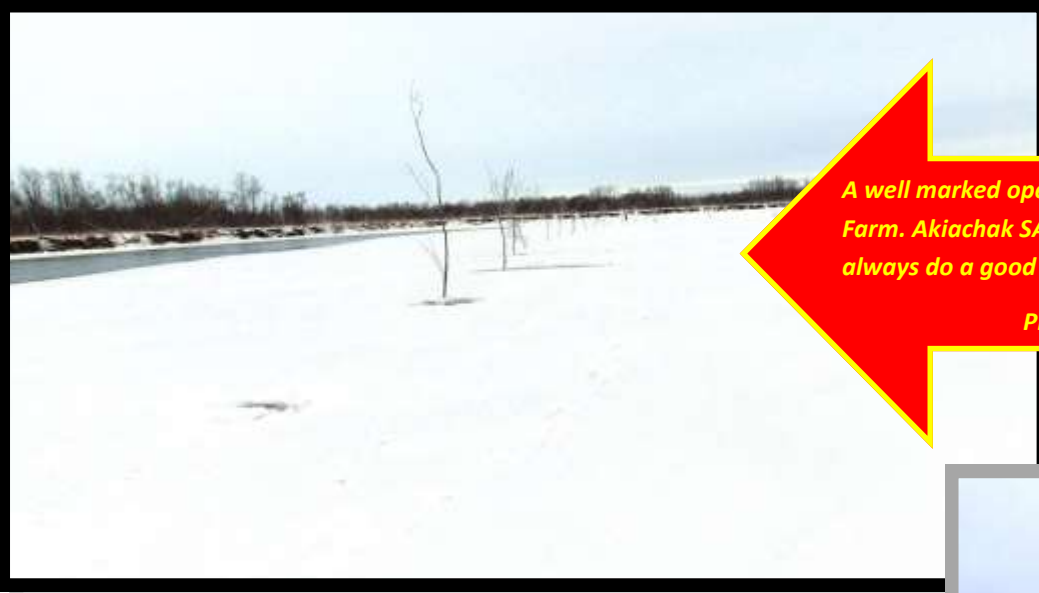
A well marked open hole just below the Akiachak Tank Farm. Akiachak SAR & Tribal Transportation Department always do a good job taking care of their area. Thanks KKI!

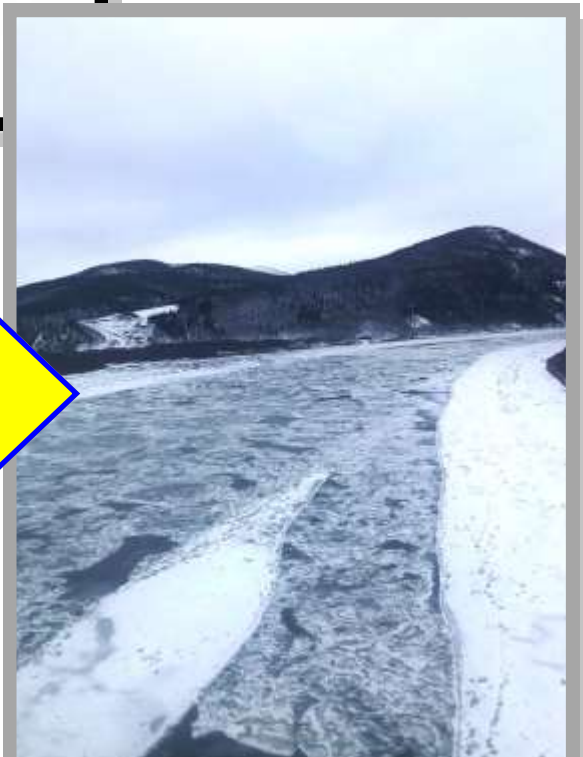
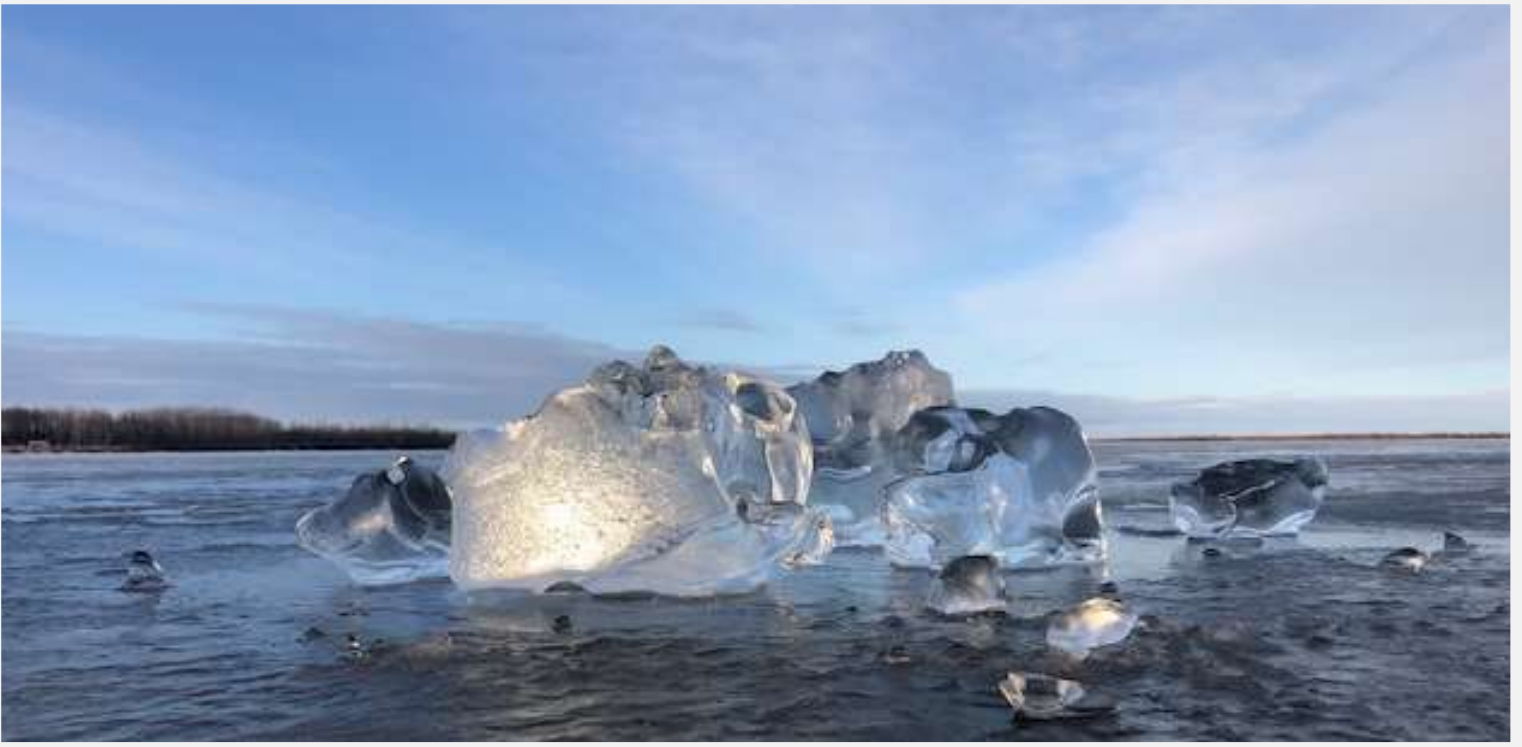
The River at Crooked Creek. The ice in the Middle Kuskokwim has just stopped running in recent days. 12" of fresh snow on top of the new ice may make it hard to thicken and get safe for travel
